TS-PIC-20003429S/20103429S  
November 2000

# AERIAL PHOTOGRAPHIC ANALYSIS COLGATE PAY DUMP SITE Baltimore, Maryland

EPA Region 3

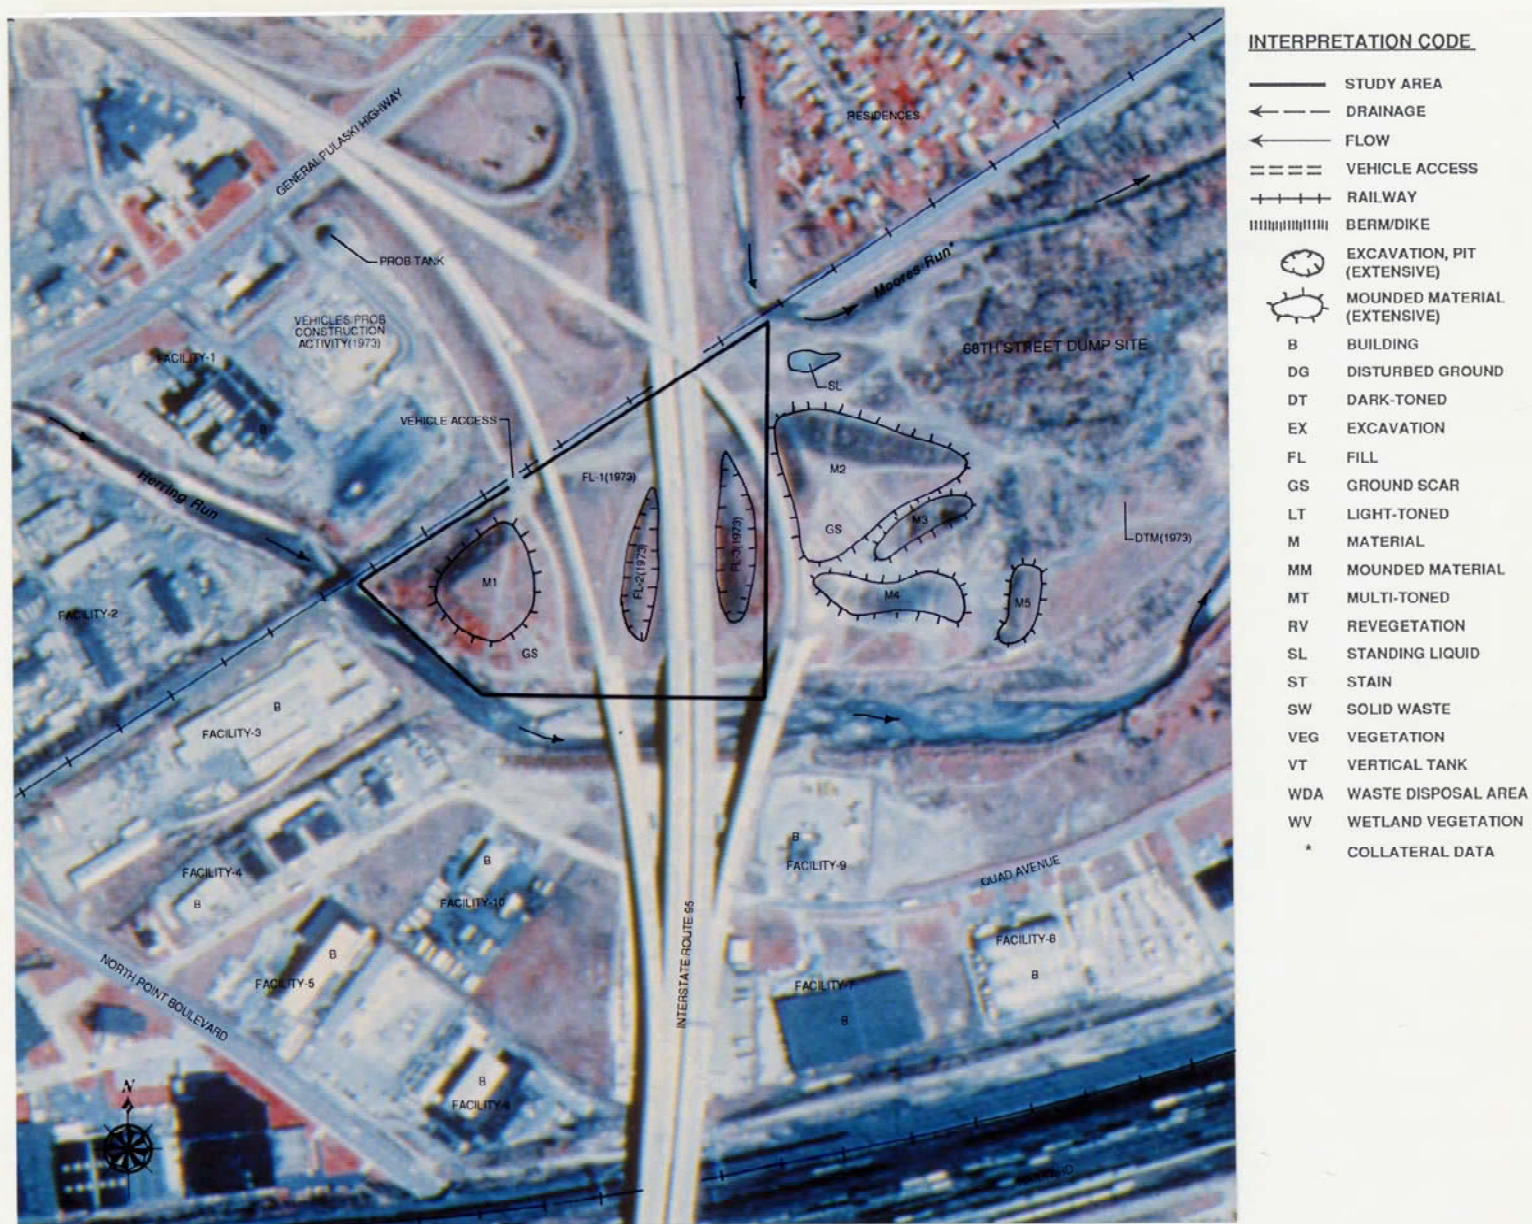
Figure 12. Colgate Pay Dump site, April 2, 1981. Approximate scale 1:4,780.

APRIL 2, 1981 (FIGURE 12)

Since 1973 the construction of Interstate 95 across the site has been completed. The three light-toned areas (FL-1 through FL-3) of probable fill material have either been consolidated within the road construction activity area (FL-1) or appear excavated (FL-2 and FL-3). Ground scars (GS) are visible along the southern side of mound M1.

Ground scars are also seen on the southern flank of mound M2. Two additional mounds (M4 and M5) are identified south of mound M3. An area with standing liquid remains visible north of mound M2. The area with dark-toned material is no longer present east of mound M3. At Facility-1 vehicles are parked in the area where probable construction activity was noted in 1973, and a probable tank is observed just south of the General Pulaski Highway.

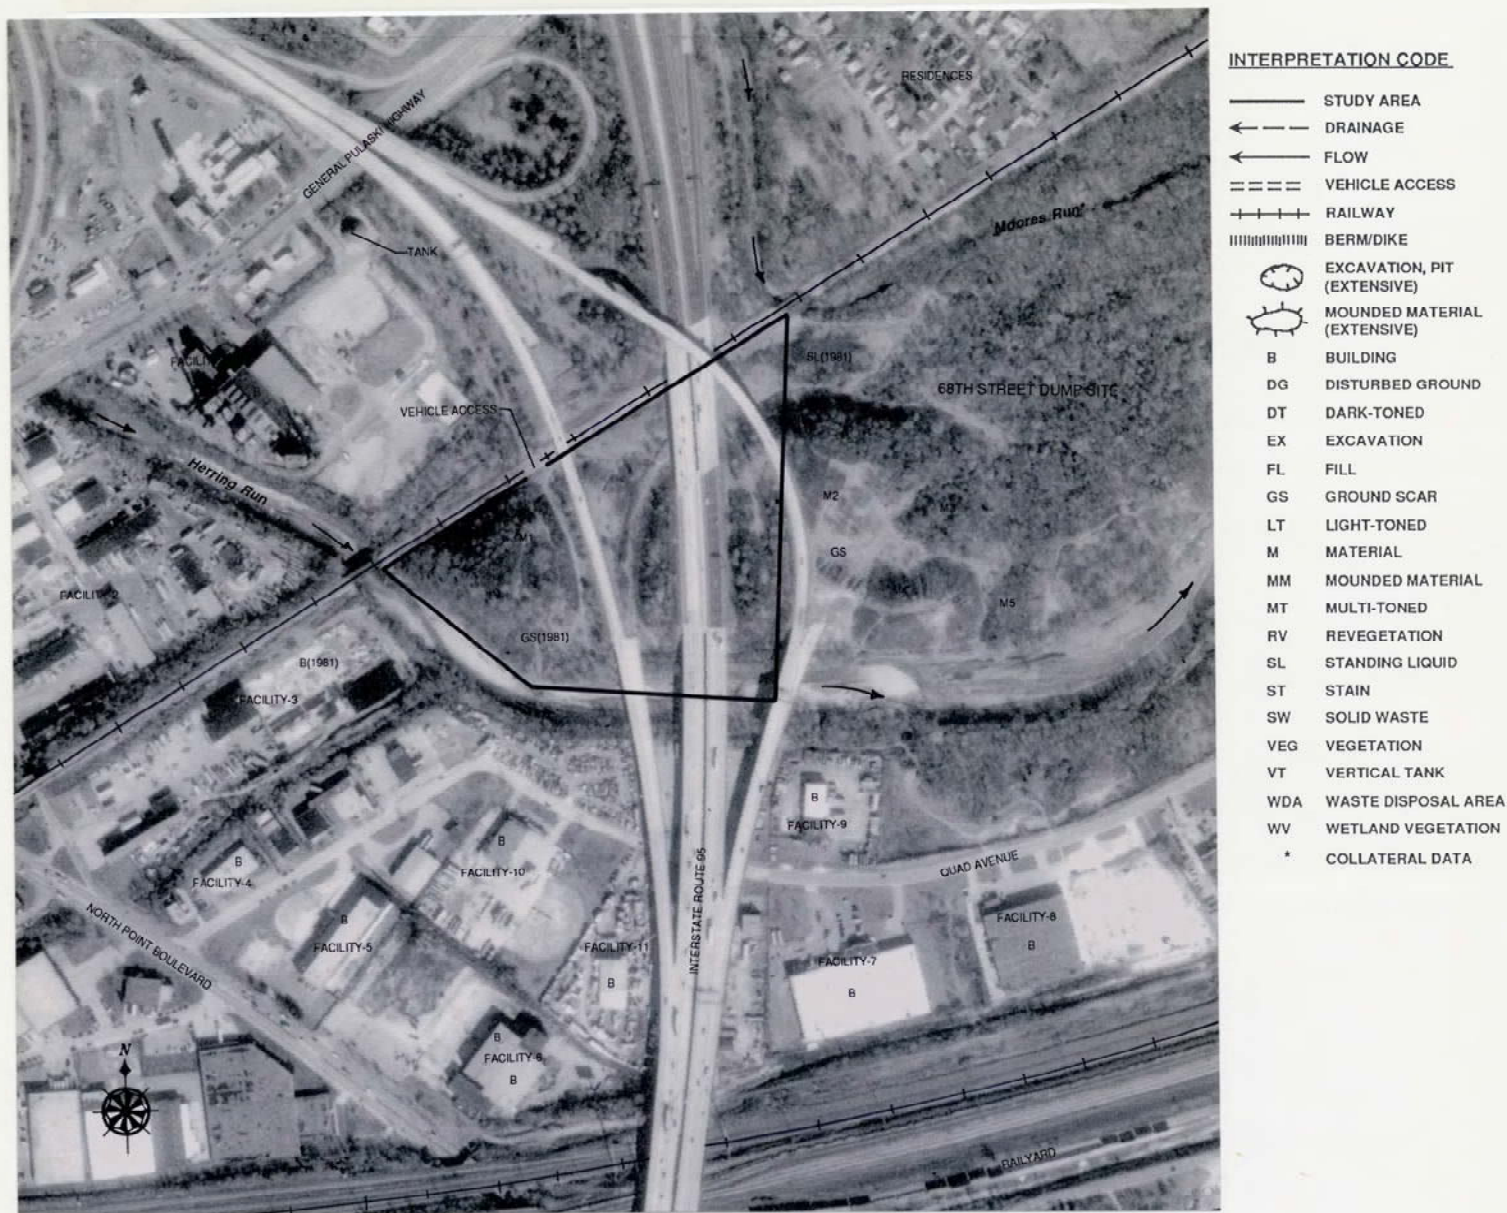
Figure 13. Colgate Pay Dump site, February 9, 1998. Approximate scale 1:4,870.

FEBRUARY 9, 1998 (FIGURE 13)

Since 1981 revegetation has obscured the delineations of mound M1 located on the site. Similarly, the surfaces of the off-site mounds (M2 through M5) have become revegetated. Ground scars remain visible along the southern side of mound M2 and along mound M4. Standing liquid is no longer visible north of mound M2.
